How to Recognize and Avoid Asbestos

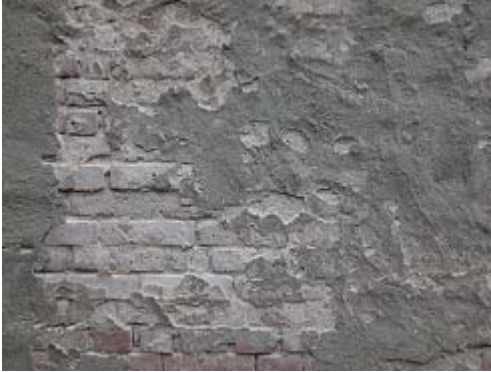
Exterior cement products and mixes often contained asbestos, to increase the thermal insulating capacity of the material

Asbestos shingles were often made from lightweight cement-based products. Both roofing and siding can appear in a range of colors, and may be textured. Shingles are very prone to releasing fibers if broken so treating these materials carefully is important.

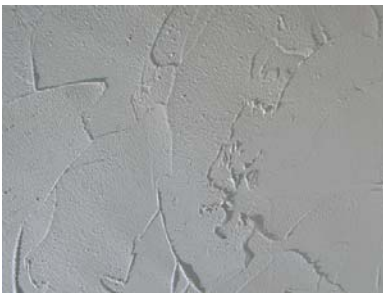
Asbestos-containing plaster wall treatments were common between the '50s and '70s.

Asbestos was commonly used in a wide range of wall, ceiling, and floor materials, from vinyl floor tiles, to textured paint and plaster wall treatments. Decorative plaster was particularly popular in the 50s, 60s, and 70s.

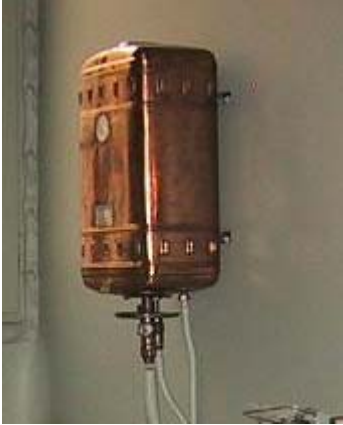
Boilers and furnaces are common asbestos points in residential, commercial, and public buildings.

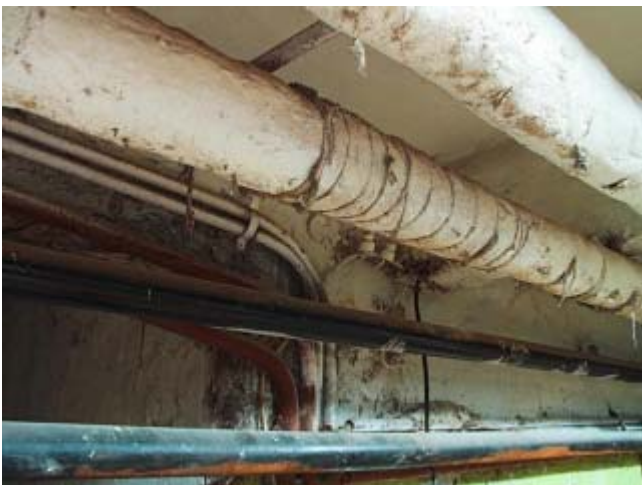
Pipe insulation is also highly likely to contain asbestos. On pipe straight sections this may be in the form of tape, corrugated paper or cardboard. On bended sections, an asbestos-containing plaster or paint was more commonly used. If the word 'transite' or 'transit' is found stamped on pipes it's a good indication asbestos is present, but if the stamp is not present it doesn't automatically mean there's no asbestos.
